P0107: MANIFOLD ABSOLUTE PRESSURE/BAROMETRIC PRESSURE CIRCUIT LOW INPUT

What Does The P0107 Code Mean?

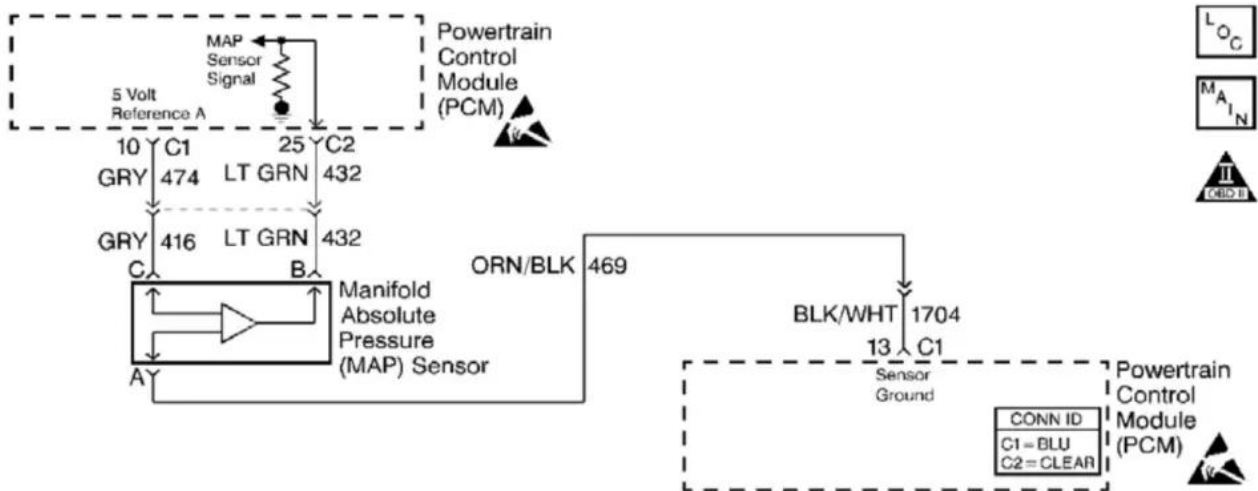
P0107 wiring diagram

Inside the MAP sensor is a resistor that moves in relation to manifold pressure. The resistor varies the voltage between about 1 volt to 4.5 volts (depending on engine load) and that voltage signal is returned to the PCM to indicate manifold pressure (vacuum). This signal is essential for the PCM to determine fuel delivery. A P0107 DTC is set when the PCM sees that the MAP signal voltage is less than .25 volts which is too low.
