P0122: THROTTLE POSITION SENSOR/SWITCH A CIRCUIT LOW INPUT

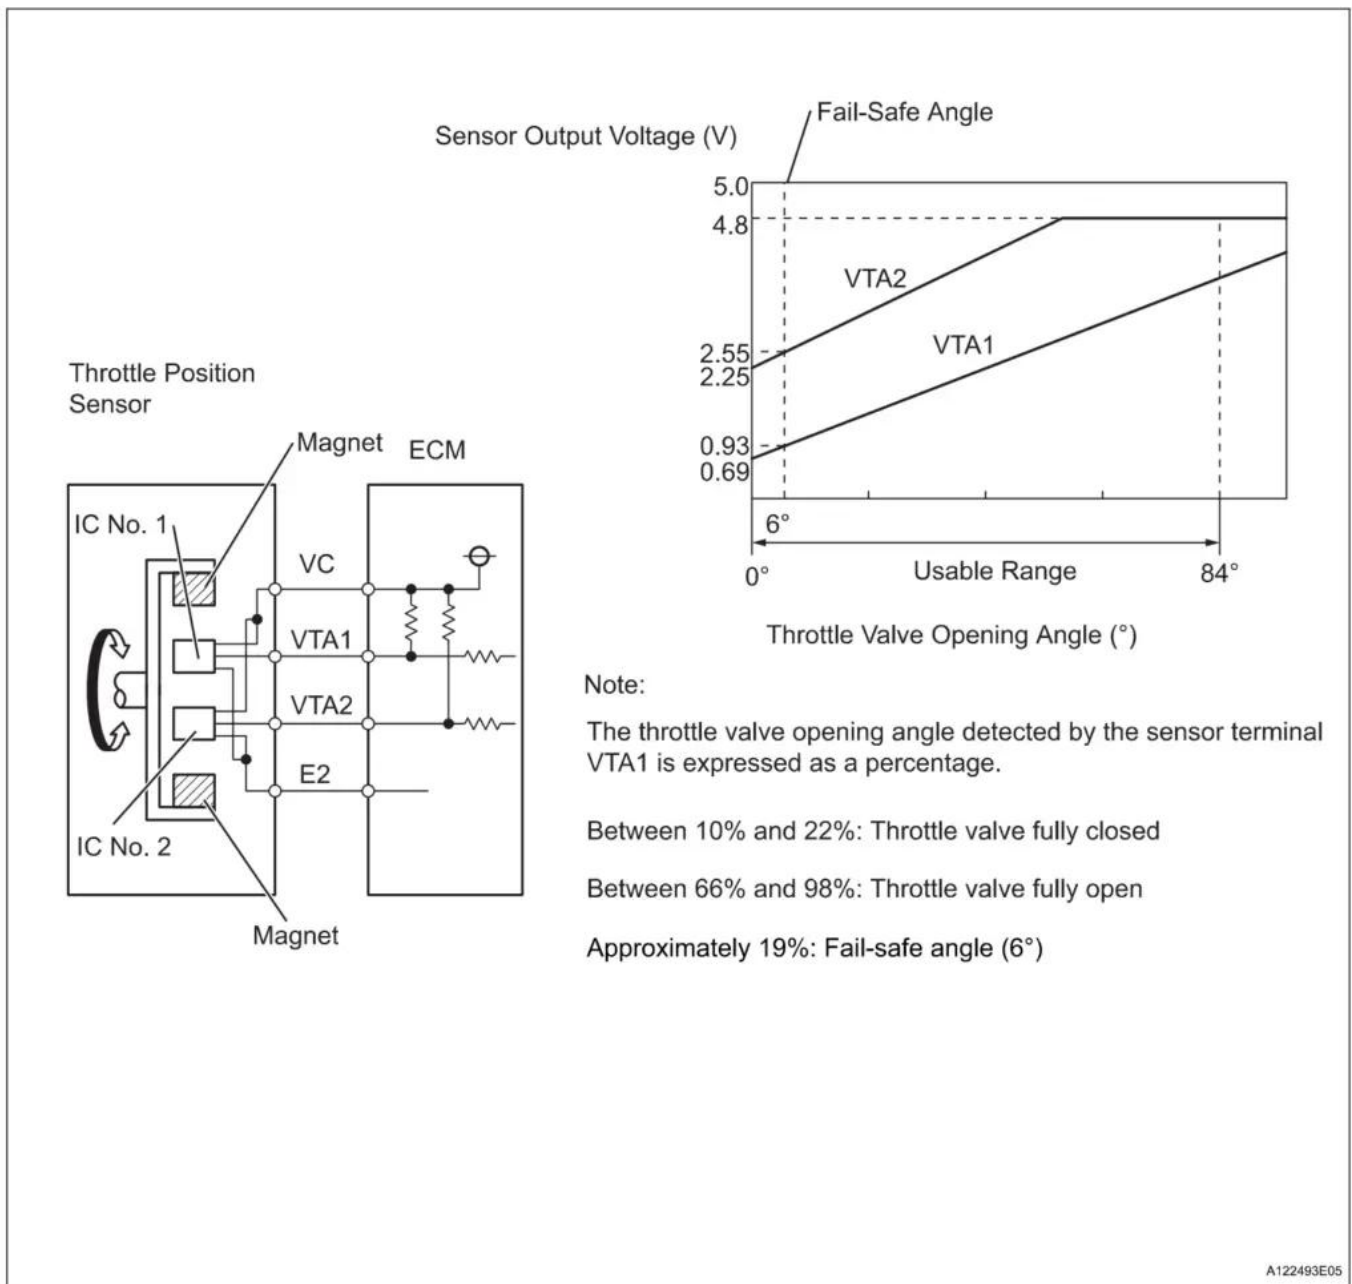
P0122 wiring diagram

A P0122 code means that the the vehicle's computer has detected that the TPS (throttle position sensor) "A" is reporting too low a voltage. On some vehicles that lower limit is 0.17 – 0.20 volts (V). In simple terms, the throttle position sensor is used to determine what position the throttle is at.

Did you adjust it when you installed it? If the signal value is less than .17V then the PCM sets this code. Could be an open or a short to ground in the signal circuit. Or you may have lost the 5 Volt reference voltage.

- Carefully check the throttle position sensor (TPS), wiring connector, and wiring for breaks, etc. Repair or replace as necessary
- Check the voltage at the TPS (refer to a service manual for your vehicle for specific information). If the voltage is too low that is indicative of a problem. Replace if necessary.
- If recently replaced the TPS may need to be adjusted. On some vehicles the installation instructions call for the TPS to be properly aligned or adjusted, consult a repair manual for specifics.
- If there are no symptoms at all, the problem may be intermittent and clearing the code may resolve the issue temporarily. If this is the case then you should definitely check the wiring to be sure it's not rubbing on anything, grounding, etc. The code may come back.
