## P2017: INTAKE MANIFOLD RUNNER POSITION SENSOR / SWITCH CIRCUIT HIGH BANK 1

### OVERVIEW

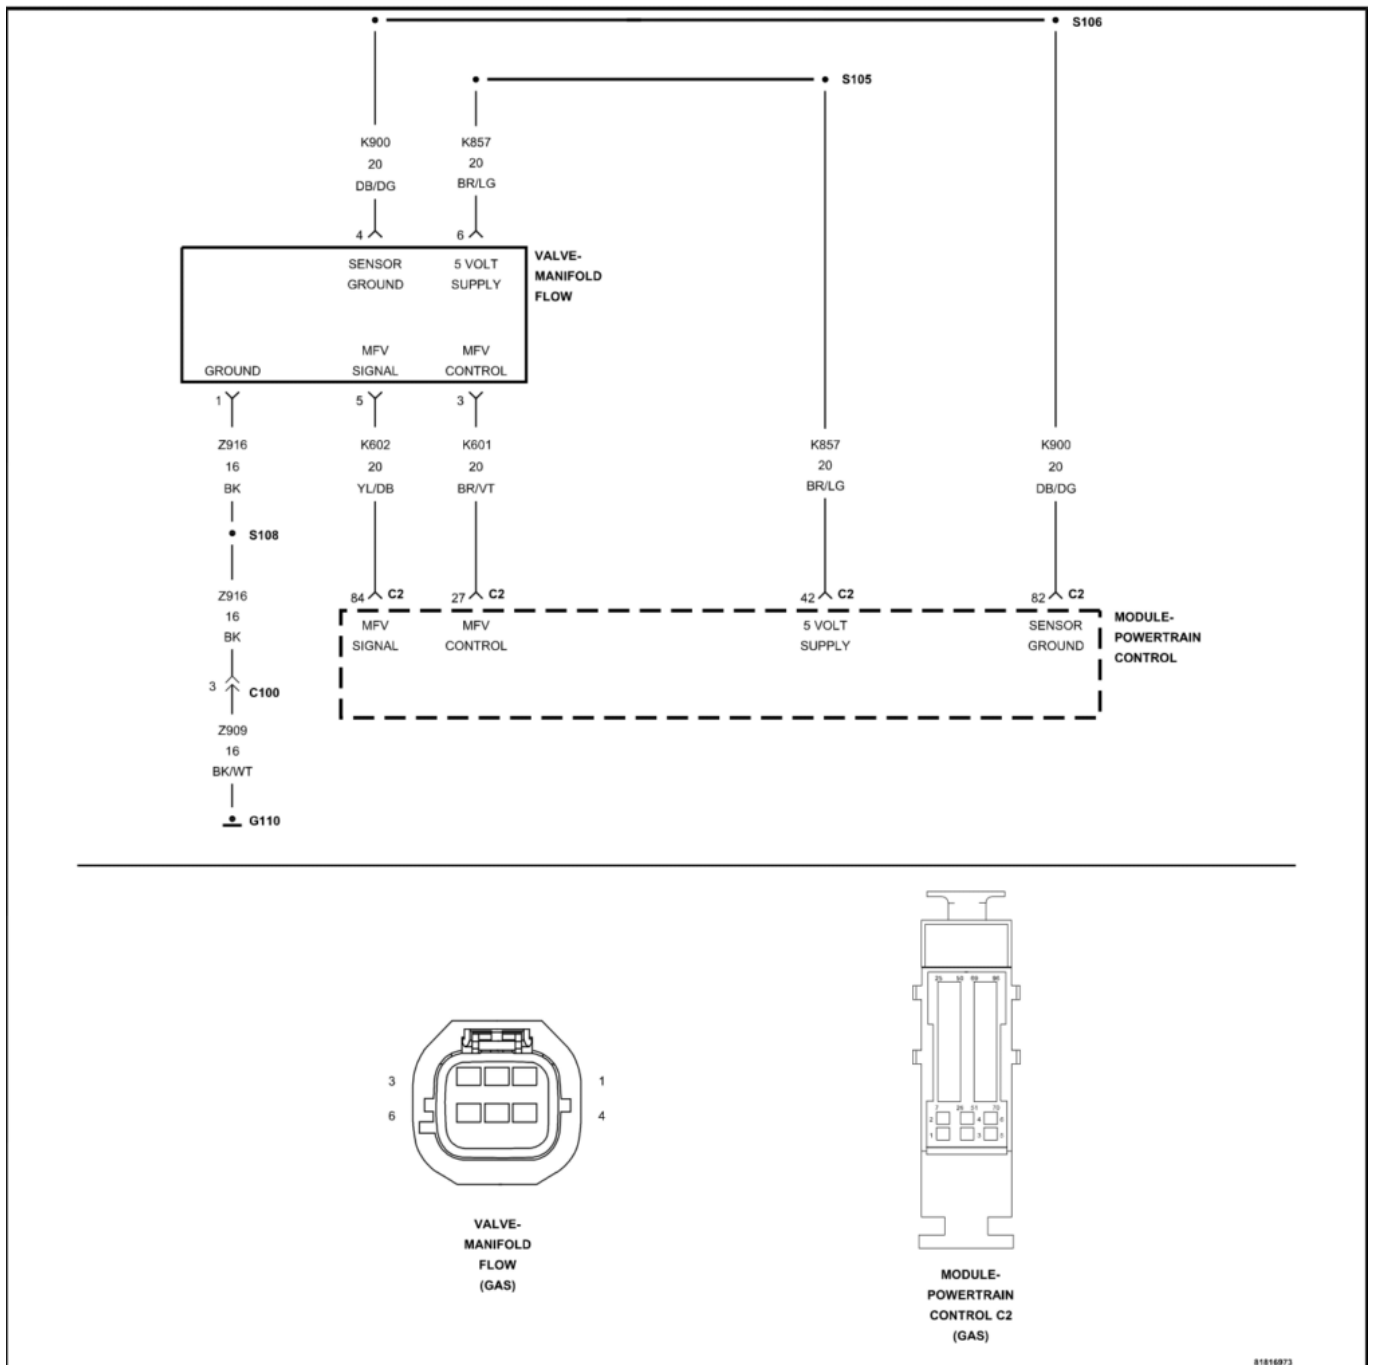
P2017 wiring diagram

With the valve disconnected, the red voltmeter lead should be attached to the IMRC valve power wire and the black voltmeter lead connected to ground. Turn the ignition switch to the “run” position and check for voltage. It should be pretty close to battery voltage (12 volts). If not, then this is the circuit that has the problem. If it does have 12 volts, reconnect the wires to the valve and

check for voltage on the ground wire (PCM control wire). It too should be pretty close to battery volts as well. If not, then the IMRC valve/solenoid is suspected to be open/shorted at this time.
