## P2141: EXHAUST GAS RECIRCULATION THROTTLE POSITION CONTROL CIRCUIT "A" LOW

### What Does The P2141 Code Mean?

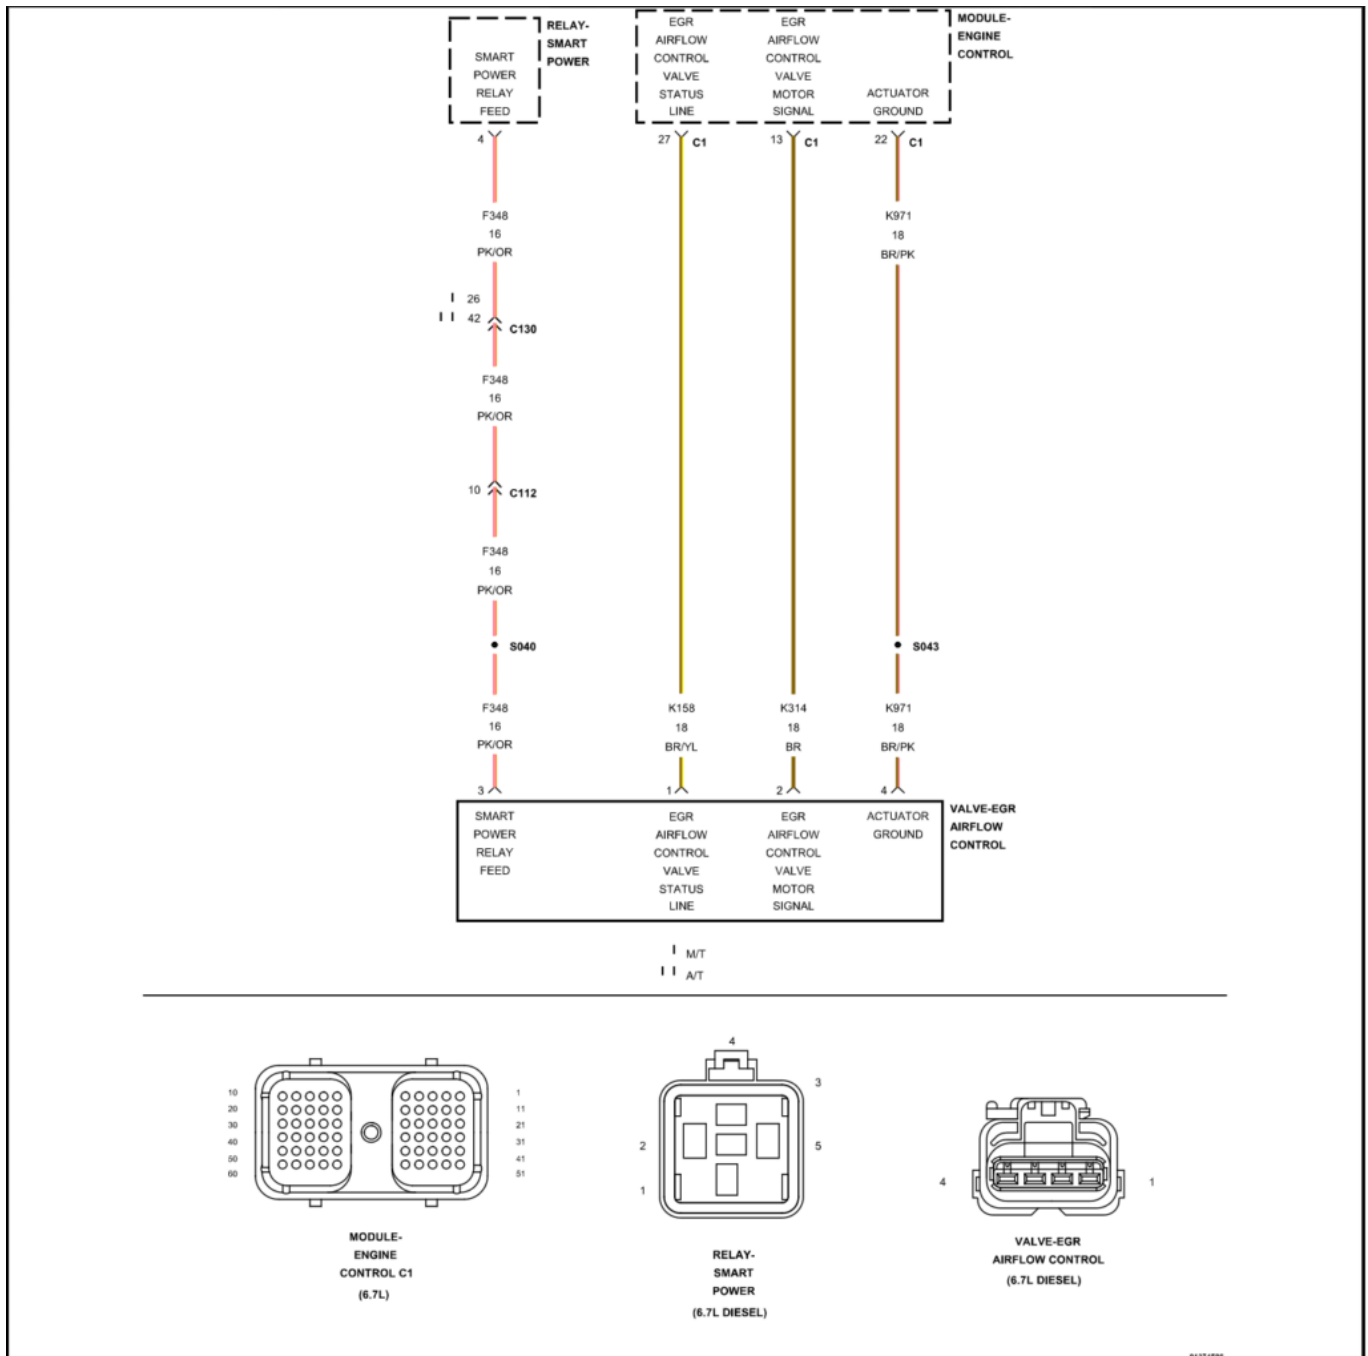
P1241 wiring diagram

The Powertrain Control Module (PCM) tells the Exhaust Gas Recirculation (EGR) throttle control valve where to position itself. This code is looking at the voltage signals from the EGR throttle control valve to determine if they are correct based on inputs to the PCM. This code could have been set most likely due to electrical issues. In this case, P2141 refers to a low voltage condition on that control circuit.

If the P2141 code does return, we will need to test the EGR throttle control valve and its associated circuits. Typically, there are either 3 or 4 wires at the EGR throttle control valve. Disconnect the harness going to the EGR throttle control valve.

With a Digital Volt Ohm Meter (DVOM), test the EGR throttle control valve signal circuit (Red lead to the valve's signal circuit, black lead to a good ground). If there is no 5 volts to the valve, or if you see 12 volts at the valve, repair the wiring from the PCM to the valve, or possibly a bad PCM.
