## P245D: EXHAUST GAS RECIRCULATION COOLER BYPASS CONTROL CIRCUIT HIGH

### What Does The P245D Code Mean?

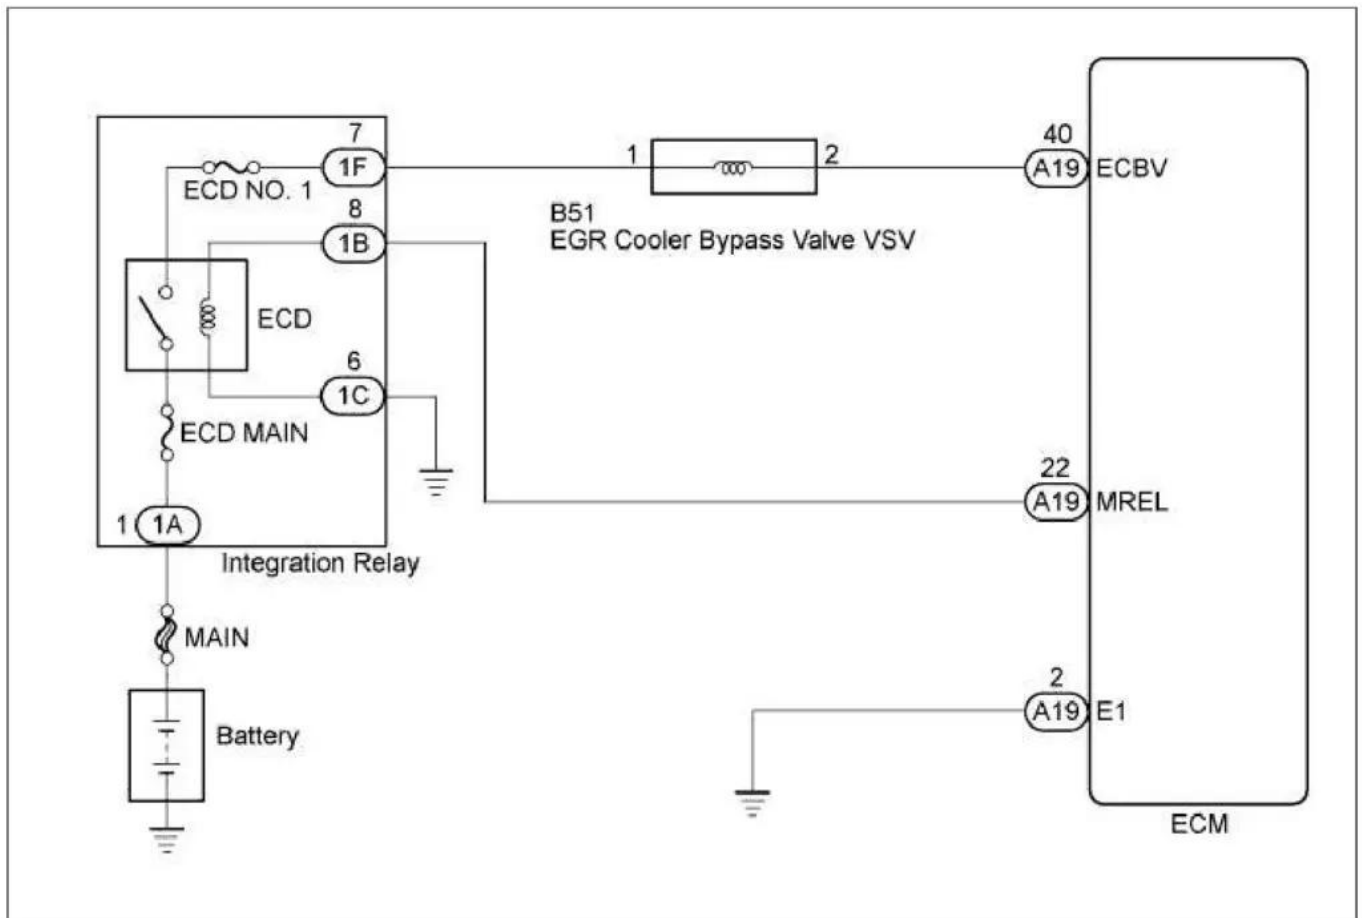
P245D wiring diagram

The purpose of the EGR cooler bypass control circuit is to open and close the EGR bypass valve under predetermined conditions to prevent the EGR cooler from being overloaded known as fouling that effects the performance and efficiency of a diesel engine.

The Engine Control Module (ECM) monitors the operation of this circuit by receiving voltage references from the EGR temperature switch and other associated components to operate the EGR cooler bypass valve returning the exhaust gases to the intake for combustion in most configurations. The location of the EGR bypass valve, EGR cooler, temperature switch and associated components are vehicle specific and vary tremendously determined by the manufacture.
