P0152: O2 SENSOR CIRCUIT HIGH VOLTAGE (BANK 2 SENSOR 1)

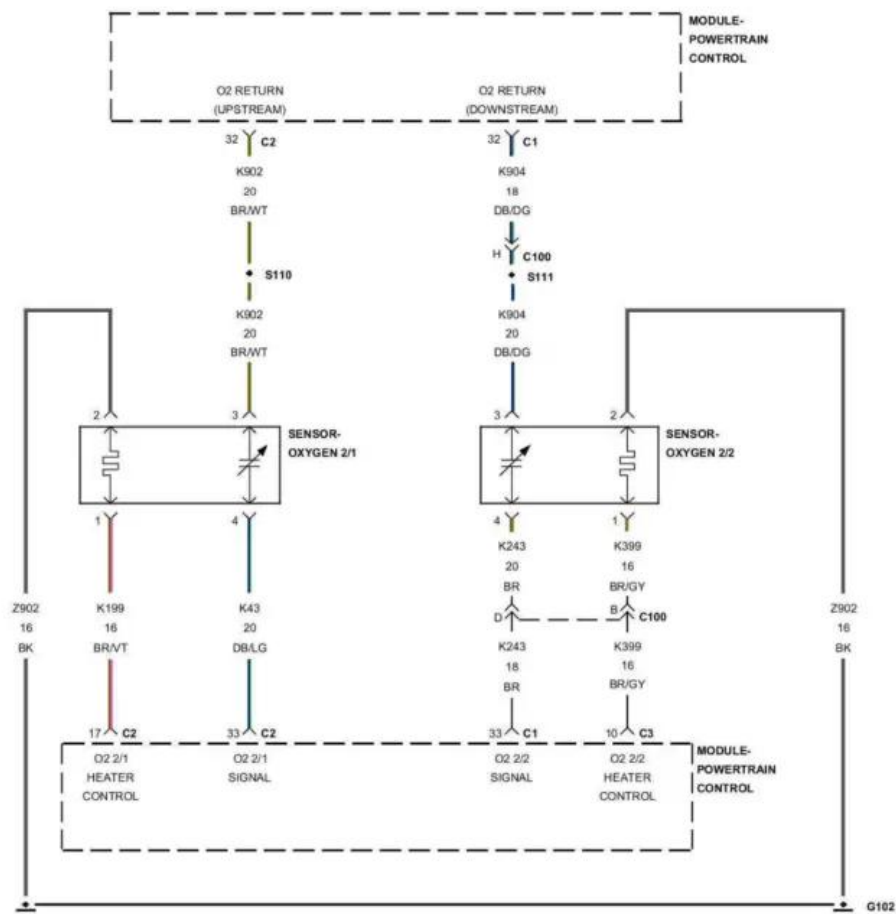
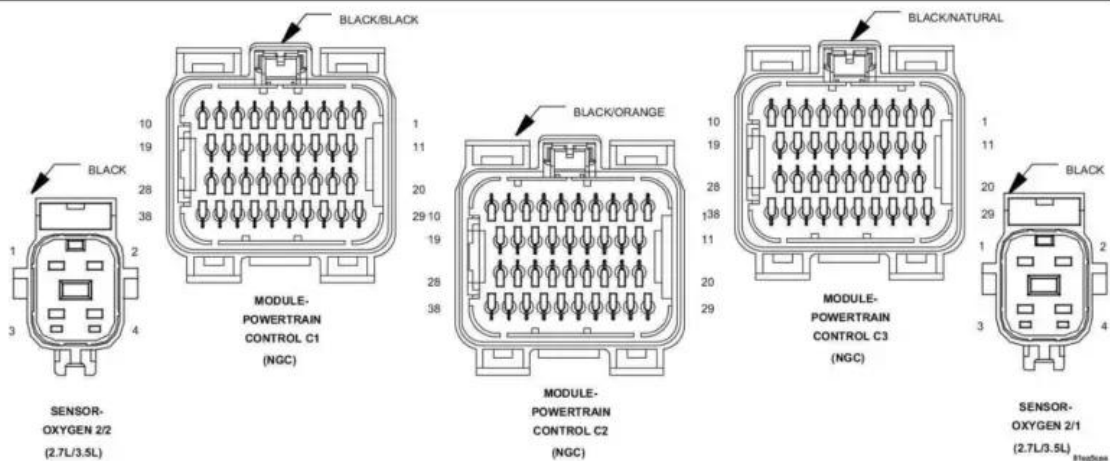
P0152 wiring diagram

A P0152 code refers to the Bank 2, sensor 1, o2 sensor. (Bank 1 would contain cylinder 1 and bank 2 is the opposite bank. Bank 2 doesn't necessarily contain cylinder 2.) "Bank 2" refers to the side of the exhaust that DOES NOT contain cylinder number 1 and "Sensor 1" indicates that it is the pre-cat sensor, or forward(first) sensor on that bank. It is a four wire sensor.

The PCM supplies a ground circuit and a reference voltage of about .5 volts on another circuit.

Also for the o2 heater there is a battery voltage supply wire and another ground circuit for that. The o2 sensor heater allows the o2 sensor to warm up faster, thus achieving closed loop in less time than it would normally take for the exhaust to warm the sensor up to operating temperature.

continuity of all four wires between the sensor and the PCM with an ohmmeter. Any resistance at all indicates a problem. Repair as necessary.
