P0251: INJECTION PUMP FUEL METERING CONTROL A MALFUNCTION (CAM/ROTOR/INJECTOR)

What Does The P0251 Code Mean?

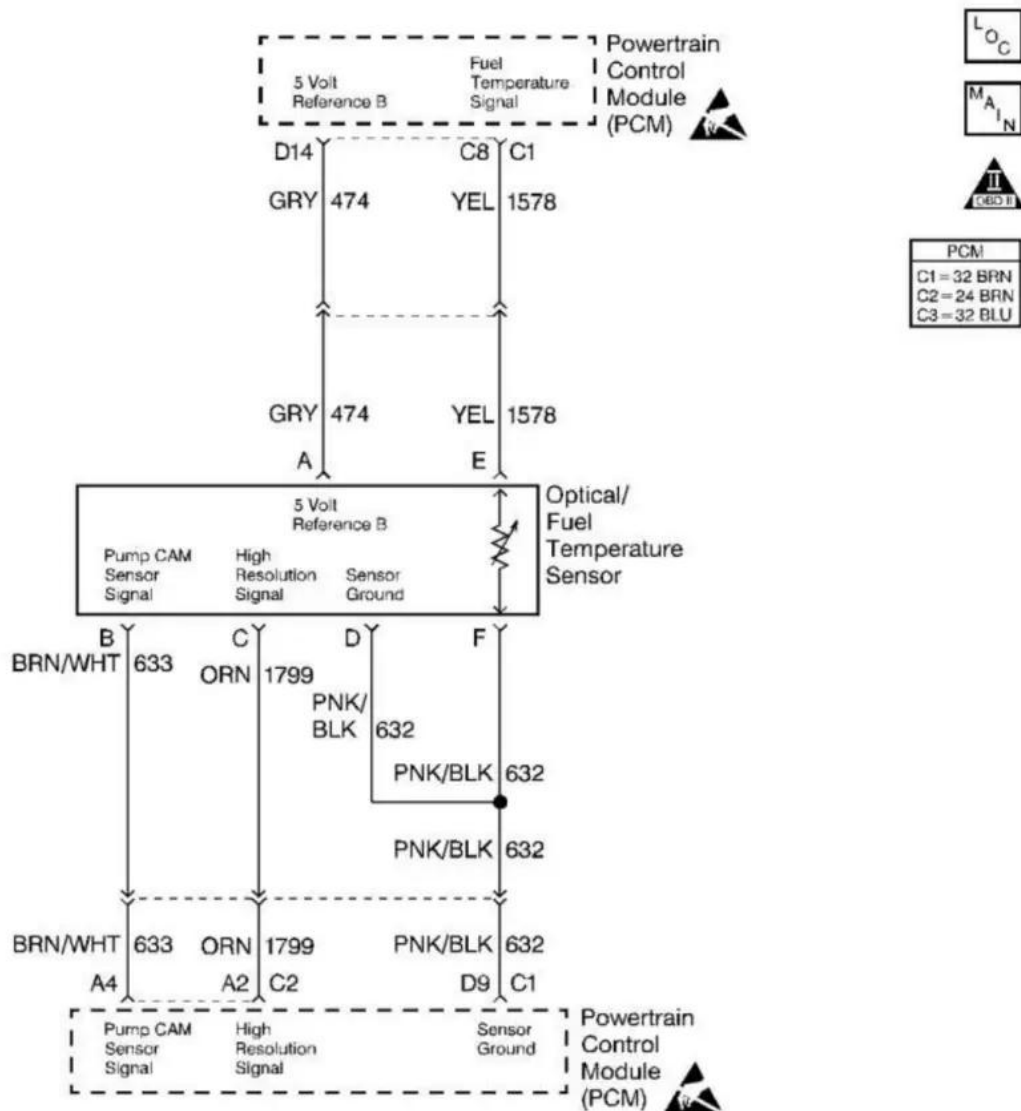
P0251 wiring diagram

The Injection Pump Metering Control Circuit "A" is usually found mounted inside / on the side of the injection pump bolted to the engine. The Injection Pump Metering Control Circuit "A" is usually made up of a Fuel Rack Position (FRP) Sensor and a Fuel Quantity Actuator.

The FRP sensor converts the amount of diesel fuel being delivered by the Fuel Quantity Actuator to the injectors into an electrical signal for the Powertrain Control Module (PCM).

Troubleshooting steps may vary depending upon manufacturer, type of FRP sensor and wire colors.

If the P0251 code does return, we will need to test the FRP sensor and its associated circuits. With the Key Off, disconnect the electrical connector at the FRP sensor. Connect a Digital Voltmeter black lead to the ground terminal at the FRP sensor wiring harness connector. Connect the red lead of the Digital Voltmeter to the power terminal at the FRP sensor wiring harness connector. Turn Key On Engine Off. Check manufacturer's specifications; voltmeter should read either 12 volts or 5 volts. If not, repair the power or ground wire, or replace the PCM.

If the prior test passed, we will need to test the signal wire. With the connector still disconnected, move the red lead of the voltmeter from the power wire terminal to the signal wire terminal. The voltmeter should now read 5 volts. If not, repair the signal wire, or replace the PCM.
