## P2004: INTAKE MANIFOLD RUNNER CONTROL STUCK OPEN BANK 1

### What Does The P2004 Code Mean?

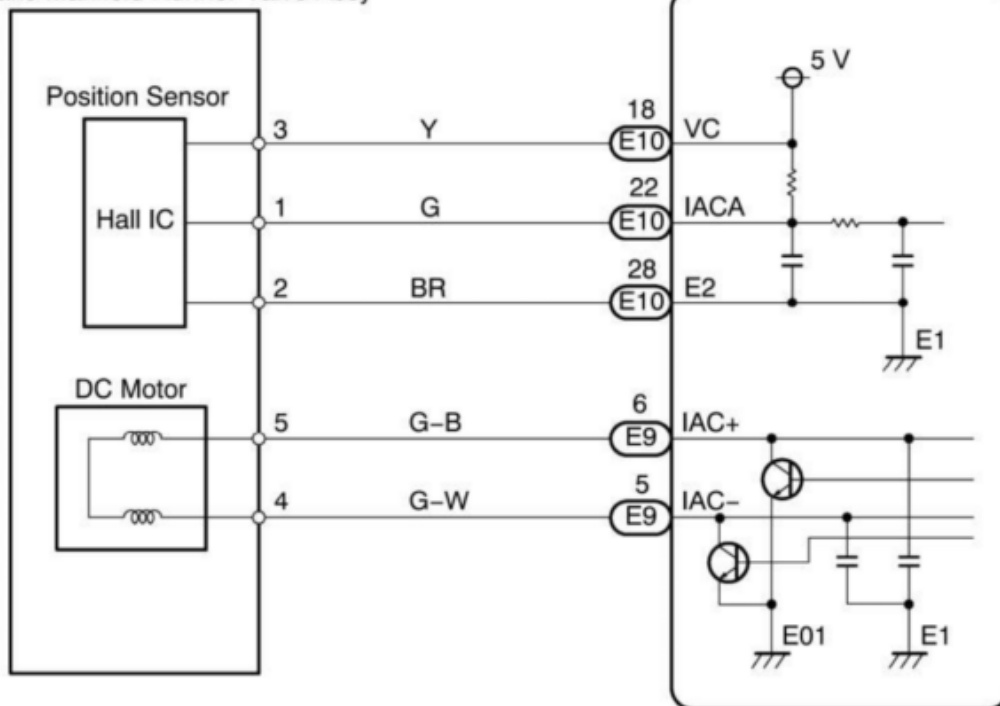
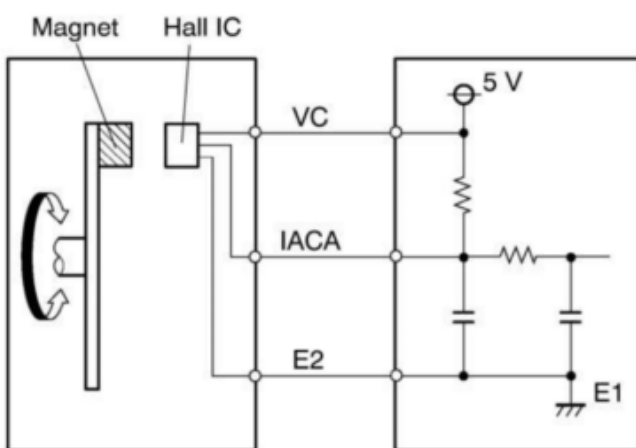
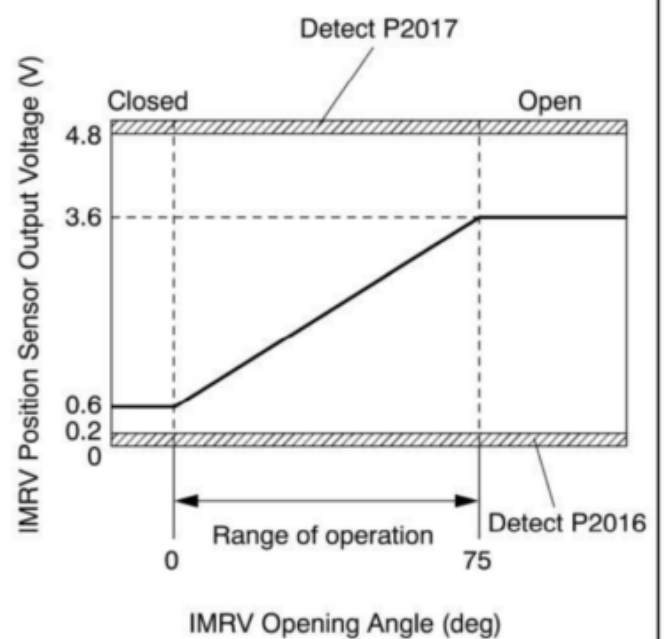
P2004 wiring diagram

I18  
Intake Manifold Runner Valve Assy

IMRV Position Sensor

ECM

If the code is reset, gain access to the IMRC actuator solenoid and IMRC runner position sensor. Consult your vehicle information source for testing recommendations for these components. Using the DVOM, perform a resistance test on both components. If either the actuator or the position sensor fails to comply with manufacturer's recommendations, replace the defective part and retest the system.

If actuator resistance and sensor resistance both comply with manufacturer's specifications, use the DVOM to test resistance and continuity on all system circuits. To avoid controller damage, disconnect all related controllers before testing. Repair or replace shorted or open circuits as needed.
