P2098: POST CATALYST FUEL TRIM SYSTEM TOO LEAN BANK 2

What Does The P2098 Code Mean?

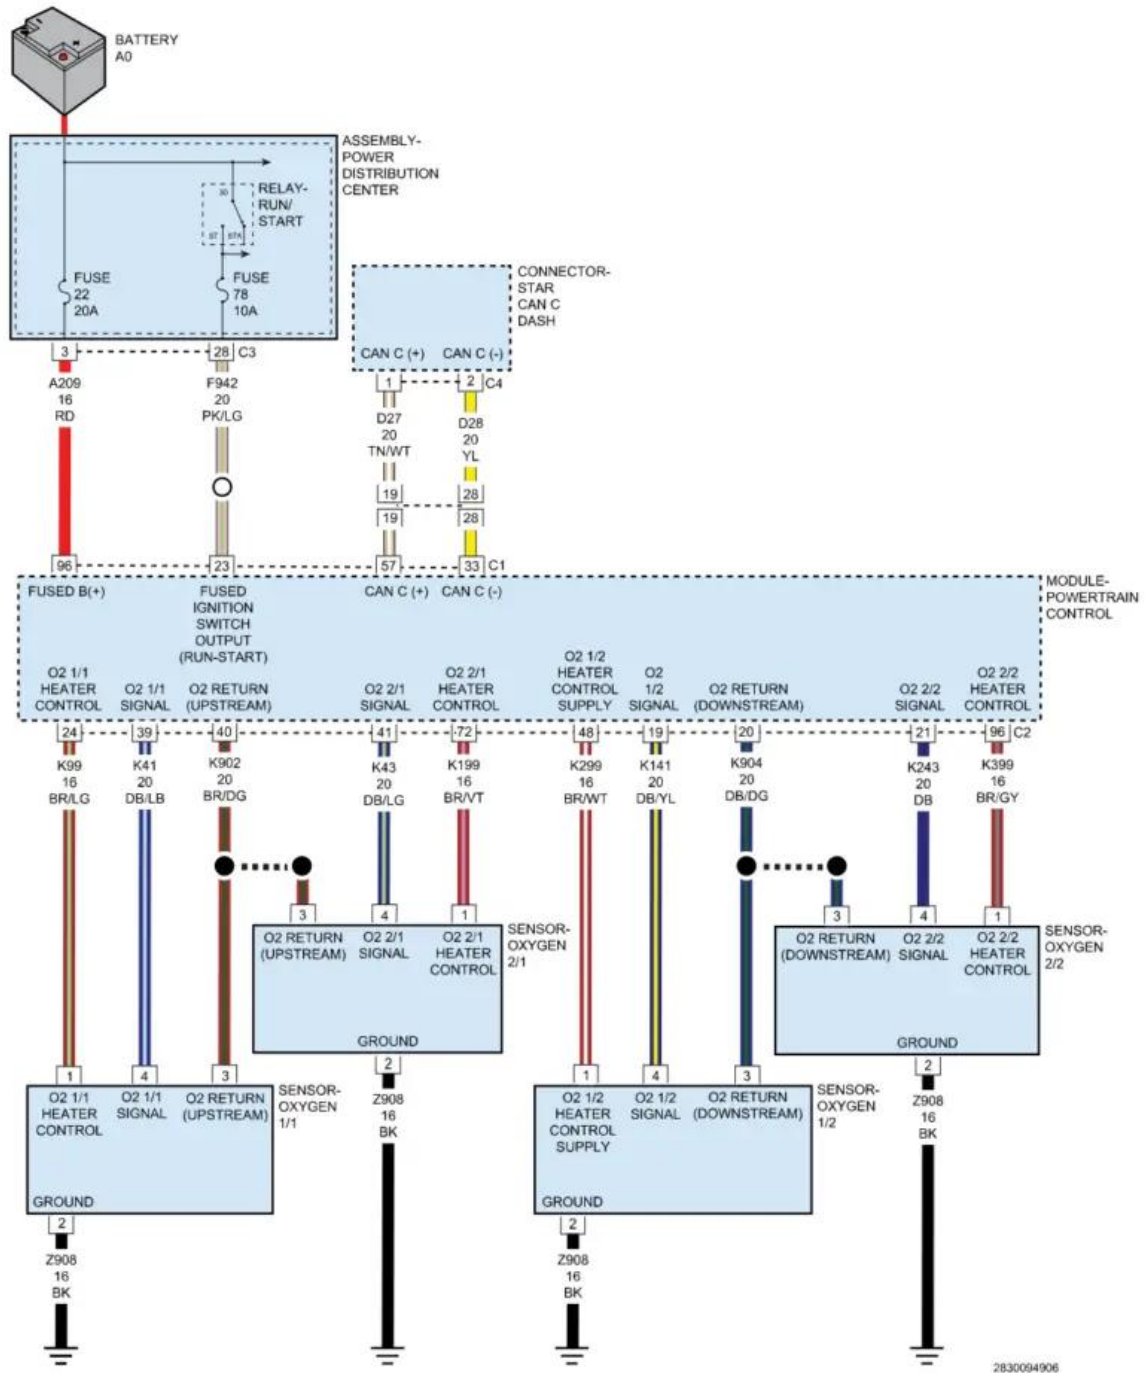
P2098 wiring diagram

A series of oxygen sensors in the exhaust system signal the fuel mixture ratio at all times. Each exhaust system with a catalytic converter will have two sensors — one between the engine and the converter and one after the converter.

When the sensors and converter are operating properly, the front sensor will have a higher count than the rear sensor indicating a functioning converter. When the front and rear sensor agree, the front oxygen sensor has failed, the converter is plugged or another component is causing the oxygen sensor to give an erroneous signal.
