P2197: O2 A/F SENSOR SIGNAL BIASED/STUCK LEAN (BANK 2 SENSOR 1)

What Does The P2197 Code Mean?

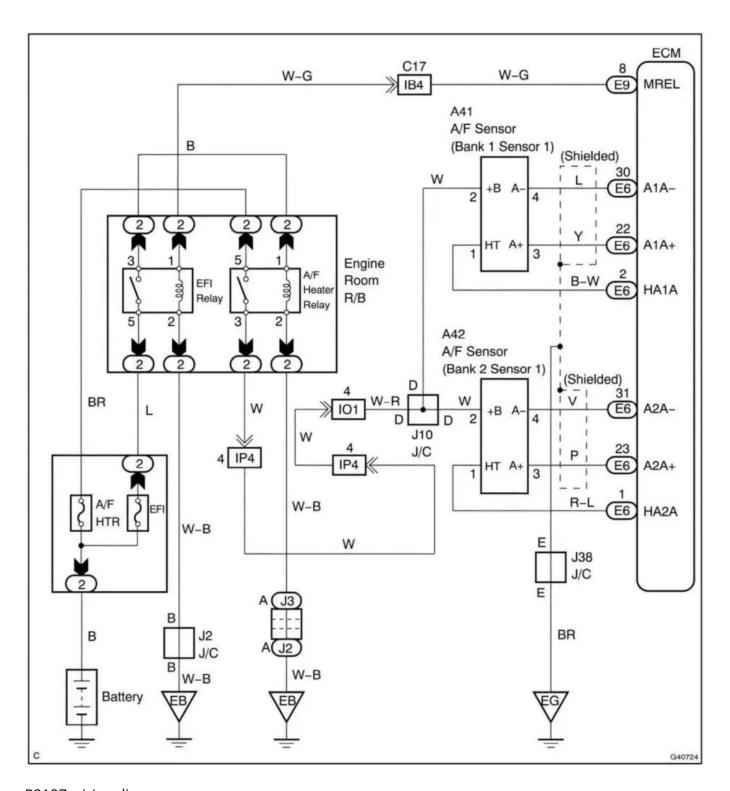
P2197 wiring diagram

This code specifically refers to the sensor between the engine and catalytic converter (not the one behind it). Bank #2 is the side of the engine that does not contain cylinder #1.
