P2307: IGNITION COIL C PRIMARY CONTROL CIRCUIT HIGH

What Does The P2307 Code Mean?

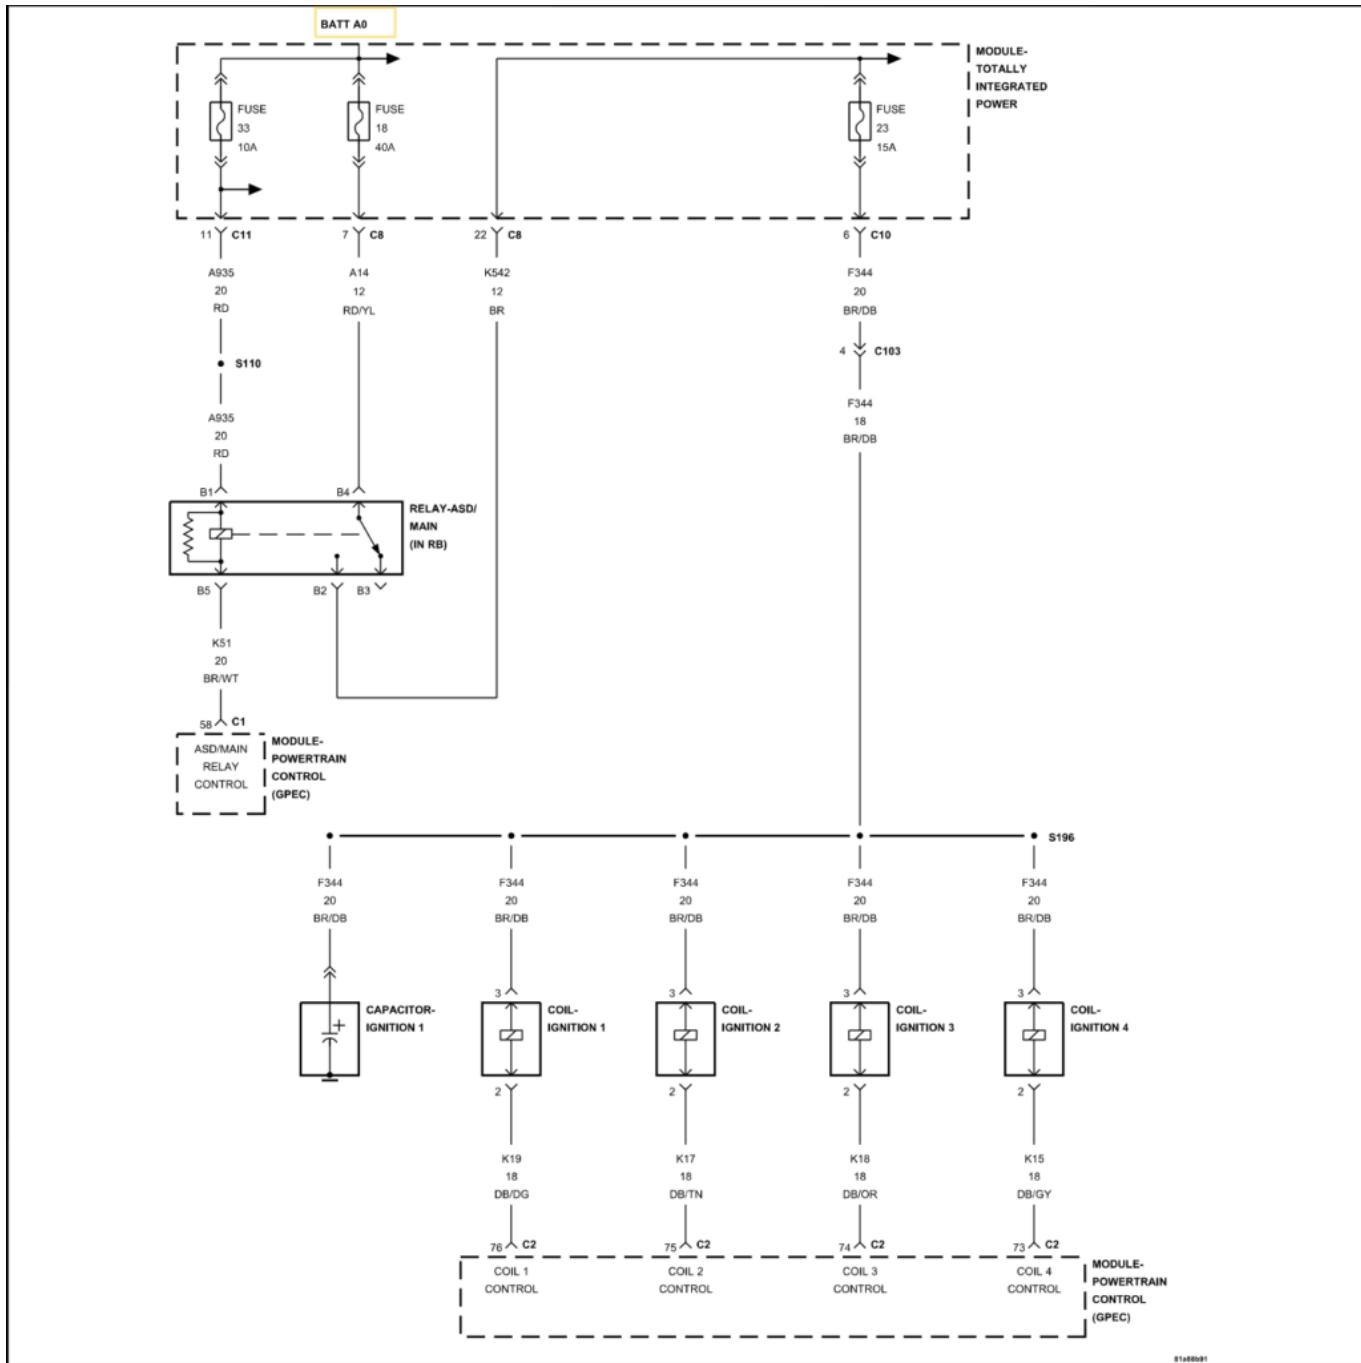
Primary circuits of the ignition coil are the wires which supply battery voltage to the coil. Voltage is delivered through fuses, relays, and various other sources. The high-energy ignition boot, spark plug boot, or spark plug wire is NOT considered a primary circuit.

Typically, the ignition coil is supplied with battery voltage and ground. When the ground signal is interrupted (momentarily), the ignition coil emits a high voltage spark which also fires the spark plug.

P2307 wiring diagram

Use the DVOM to test voltage and ground circuits at the ignition coil in question. If no voltage is detected, check the system relay and related fuses. Replace defective relays and/or blown (or otherwise defective) fuses as required.

If voltage and ground are detected at the coil, test the corresponding ground circuit at the PCM connector with the engine running. If ground pulse is detected there, suspect an open circuit between the coil in question and the PCM. If no ground pulse is discovered there, suspect a defective PCM, or a programming error.
