## P2631: O2 SENSOR PUMPING CURRENT TRIM CIRCUIT HIGH BANK 2 SENSOR 1

### What Does The P2631 Code Mean?

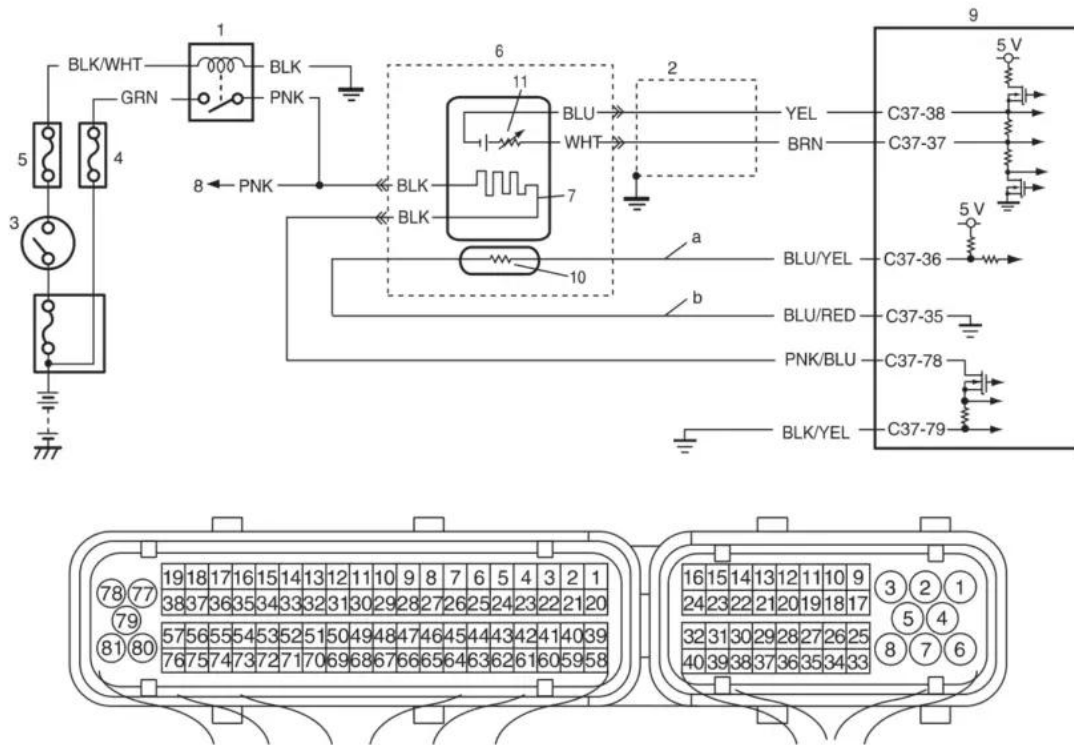
I6JB01110107-01

| a. Adjusting resistor (+) circuit of A/F sensor (bank-1) | 3. Ignition Switch | 7. A/F sensor heater | 11. A/F sensor element |
| b. Adjusting resistor (-) circuit of A/F sensor (bank-1) | 4. O2 HTR fuse | 8. To A/F sensor (bank-1), HO2S (bank-1 and -2) | |
