What Does The P0336 Code Mean?

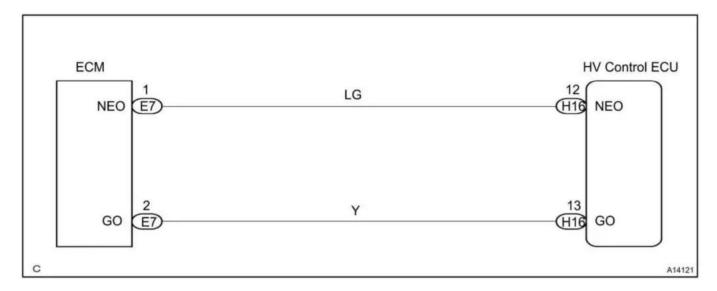
P0336 wiring diagram

The crankshaft position sensor (CKP) is usually a two wire sensor: a signal and a ground. The CKP sensor consists of (usually) a permanent magnent sensor that is mounted in front of a reluctor (toothed) wheel mounted to the crankshaft.

As the reluctor wheel passes in front of the crank sensor, an A/C signal is produced that varies according to engine speed. The PCM (powertrain control module) uses this A/C signal to interpret engine RPM.
