P2237: O2 SENSOR POSITIVE CURRENT CONTROL CIRCUIT/OPEN BANK 1 SENSOR 1

What Does The P2237 Code Mean?

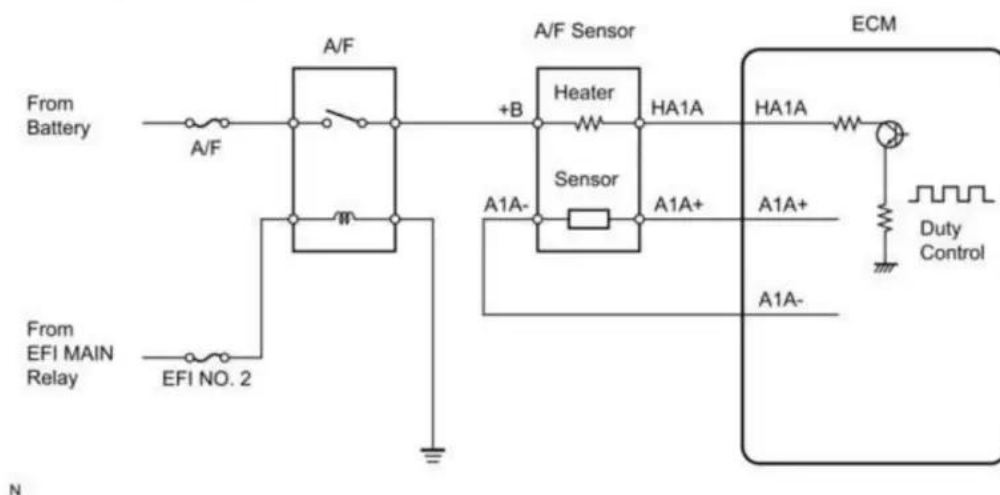
P2237 wiring diagram

The O2 sensor harness connector plugs into the controller area network (CAN) which attaches the HO2S wiring harness to the PCM connector.

In a separate section of the sensor, the HO₂S is preheated using battery voltage (12-volts). When engine temperature is low, battery voltage heats up the HO₂S so that it can begin to monitor exhaust oxygen content faster.

Unplug the HO2S in question and use the DVOM to check resistance between the positive current control circuit and any ground circuits. If there is continuity, suspect a defective HO2S.
