P2738: PRESSURE CONTROL SOLENOID F CONTROL CIRCUIT LOW

What Does The P2738 Code Mean?

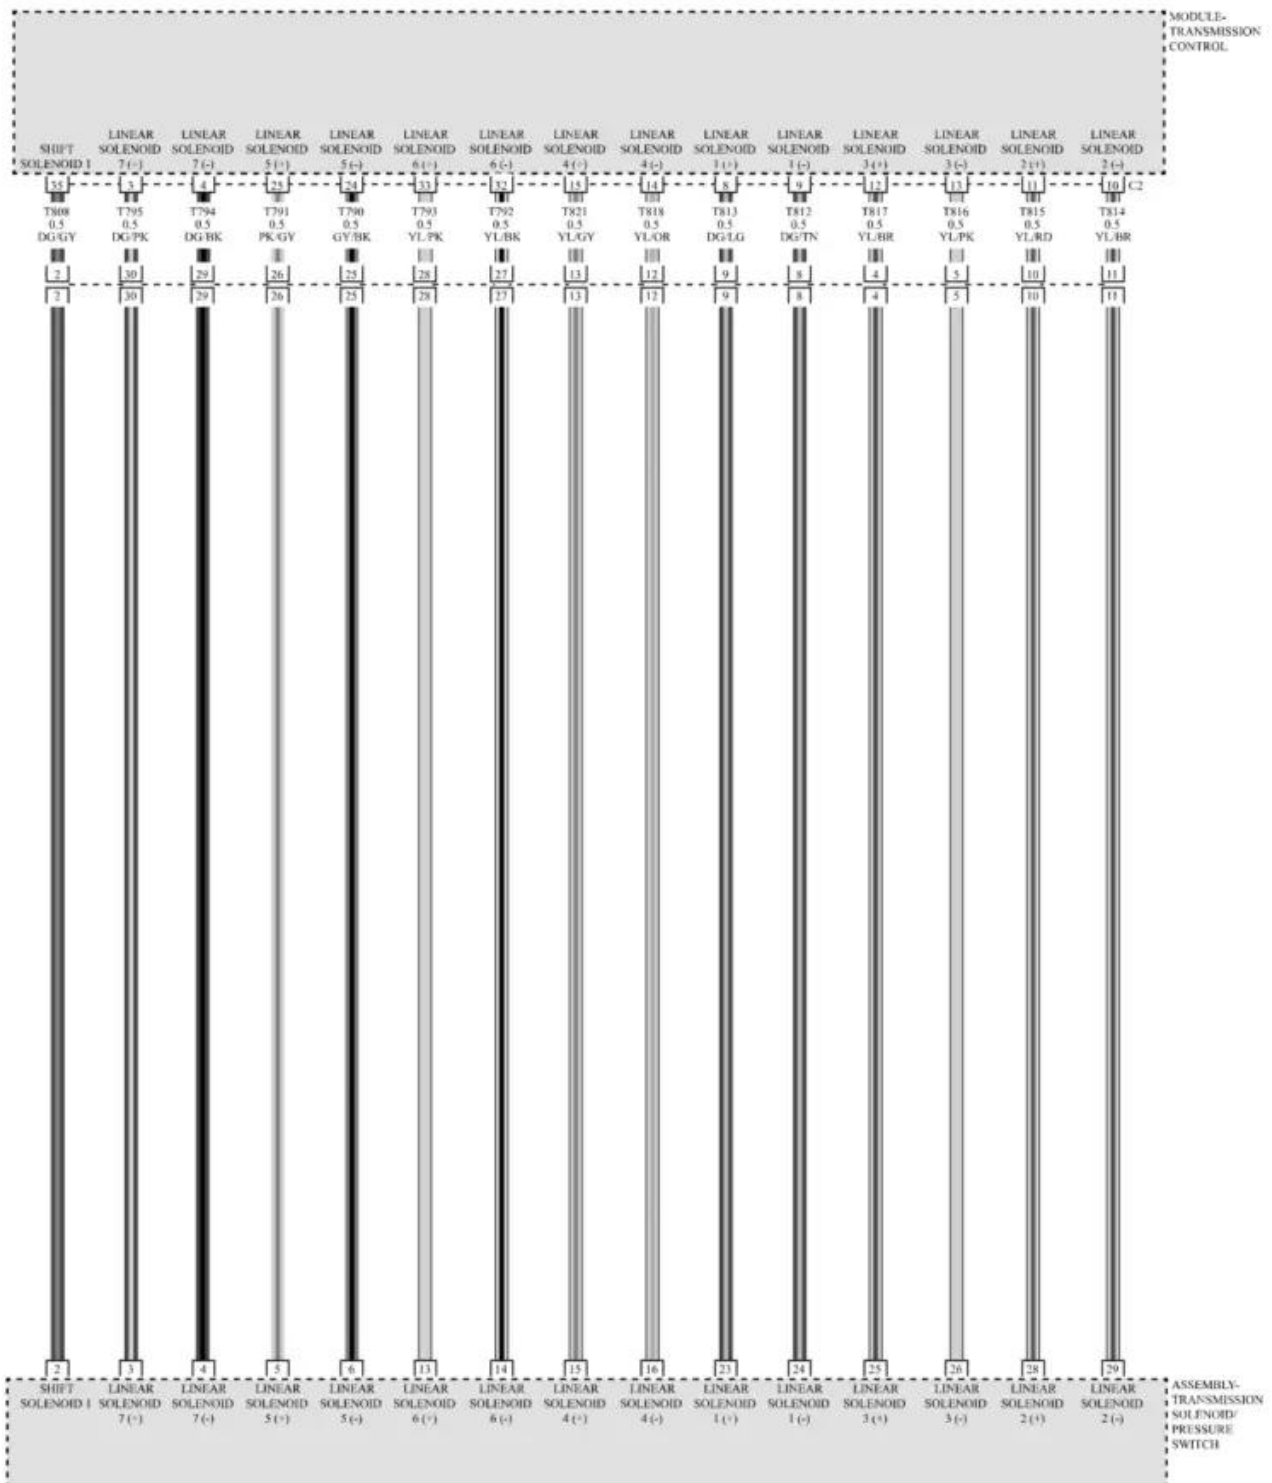
Code P2738 is set by the PCM when it detects that the pressure control solenoid "F" control circuit is experiencing a low voltage condition and therefore is not functioning properly.

P2738 wiring diagram

A detailed visual inspection to check the condition of the wiring for obvious defects is next. Check the connectors and connections for security, corrosion and damaged pins. This should include all wiring and connectors to the transmission pressure control solenoids, the transmission pump and the PCM. Based on the specific configuration, the transmission pump may be driven electrically or mechanically.
